EXISTING BUILDING CONDITIONS ANALYSIS & ASSESSMENT
EAST PENN SOCIAL HALL
403 Blue Mountain Road, Ashfield PA
East Penn Township, Carbon County PA

02 December 2016

RE: Existing Building Conditions Analysis & Assessment

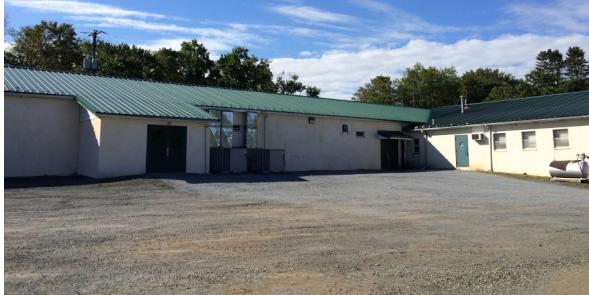
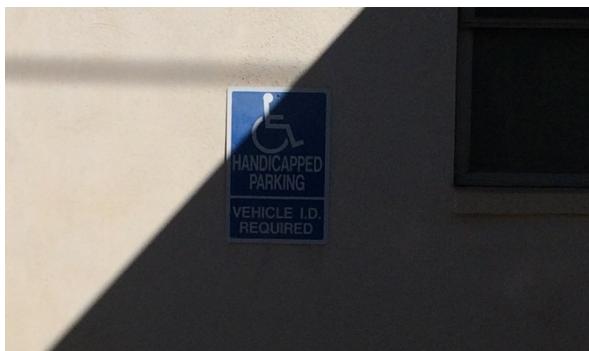
1.a

One handicapped accessible parking space is designated with a building-mounted sign only. Similar to the main parking areas, this area assumed parking space and access aisle) is not paved or indicated with painted striping. This parking space and access aisle do not comply with size / surface condition and accessible route requirements to meet current applicable handicapped accessibility standards.

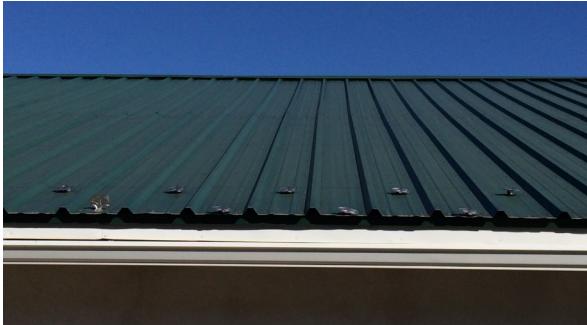
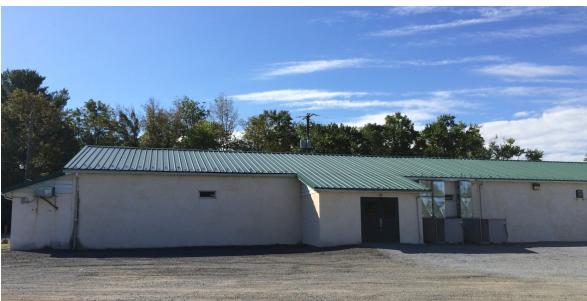
2.a

The building has a metal standing seam roof that appears to have been fairly recently replaced. Two rows of individual metal snow guards were installed in alternating panels between ribs.

The existing eave-ends of the metal roof installation are open to the elements, appearing to lack closure in the voids below corrugations. This could potentially lead to water infiltration into the building. It is unclear what type of eave starter trim was installed. Previous snow or ice accumulation appears to have been too heavy to be retained by the snow guards and deformed numerous snow guards so as to render them non-functional.

To ensure watertight conditions of the building, closure strips should be installed in gaps below corrugations and vertical end seams sealed. Replace damaged individual snow guards per manufacturer's installation recommendations with thicker gage product. Repair cracks, loose edges.

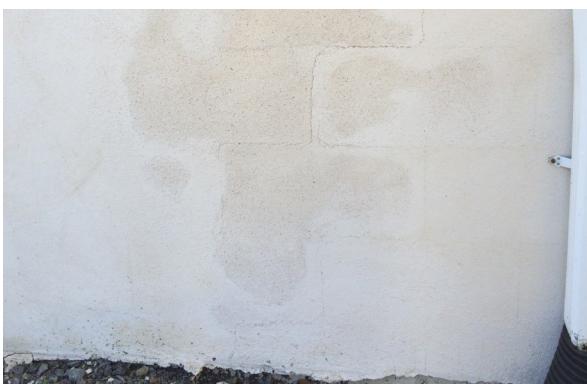
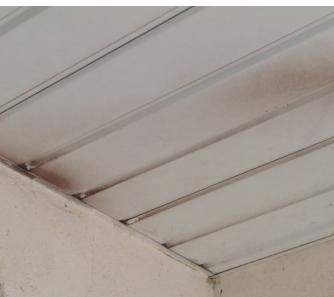
3.b

- There are areas with damaged and loose edges and cracks, some of which are telescoping masonry joints to the surface, indicating that the stucco is cracked through its thickness.
- Rust and staining is present on areas of stucco and aluminum components.

1. Repairing damage to stucco will minimize water penetration and potential future deterioration of the CMU wall.
2. Repaint previously-painted surfaces; properly prepare substrate, including removal of rust.
3. Re-fasten downspout(s) that don't properly connect to gutters, repair damaged gutters & downspouts.
4. Clean stained surfaces, refinish as necessary. Black-stained areas of mold, mildew and / or algae can be cleaned using an appropriate solution. Periodic cleaning with a mild liquid soap and water will keep the surfaces free of black stains. Painting of the stucco may be considered, but if the appropriate coating is not used it could peel, creating an ongoing maintenance issue.

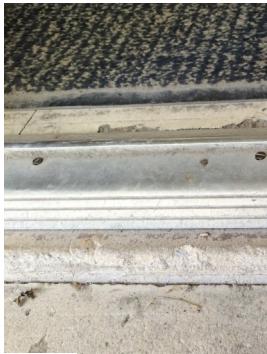
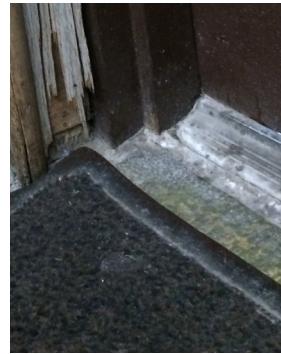
4.b

The main public entrance to the building / approach from the parking lot consists primarily of compacted gravel, with a concrete landing (approximately 3' deep) immediately outside the door. The gravel surface in this area is irregular and could pose a tripping hazard. This area would not be considered a handicapped accessible route.

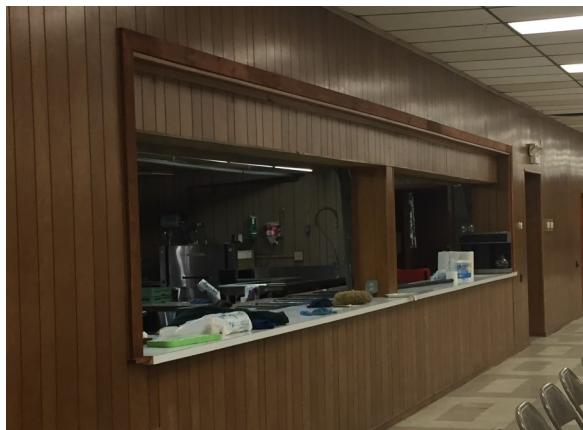
6.b.6

- There are two each Men's and Women's toilet rooms, none of which are wheelchair placement, protection of exposed piping below lavatories
- Kitchen serving counters are 38 1/4" AFF (maximum height 34" AFF).

1. Round doorknobs throughout should be replaced with lever sets, typical. Where feasible to move, or when doors are relocated, provided required clearances shall be provided. Thresholds and transition strips that exceed allowable heights (1/4" vertical change in level or combined change of 1/4" vertical plus 1/4" beveled) should be replaced with new accessible thresholds.

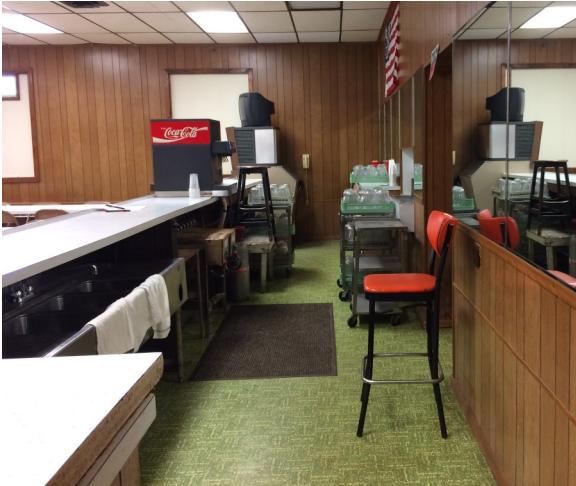
12.a.1

1. ACP ceilings are generally appropriate for this application, but panels replaced over the course of time often are mis-matched, and the brown suspension system draws negative attention to the grid, which highlights the large expanse of ceiling.
2. Plaster ceilings do not allow access to the space above, and do not offer any acoustical benefits.

1. A new APC system should be installed in the Hall, at the maximum height available. APC is highly recommended for its acoustical benefits. Both the acoustic panels and the grid should be white. If budget permits, a product with a

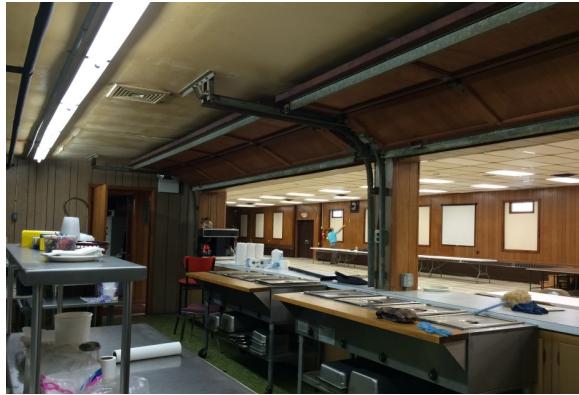
13.a.6, 13.a.7

1. The existing bar and all built-in casework, cabinets, etc., show considerable wear and deterioration of essentially all non-stainless steel surfaces. This includes delamination of plastic laminate and extensive damage of protective finish on wood cabinets.

1. All damaged plastic laminate countertops and damaged wood cabinets that are to remain shall be repaired or replaced with easily-cleanable materials, constructed without unnecessary detail or ornamentation that could harbor debris or germs.
2. The need to maintain a large, existing permanent built-in beverage bar should be carefully evaluated. Removing the existing bar and utilizing instead a smaller temporary unit would increase the amount of space available for a variety of functions, and would also resolve the accessibility issues present with the existing built-in bar. Equipment and supplies (including ice-maker, soda machine, glasses, etc.) could be relocated into a recessed alcove / closet or into a convenient beverage station incorporated into the Kitchen.

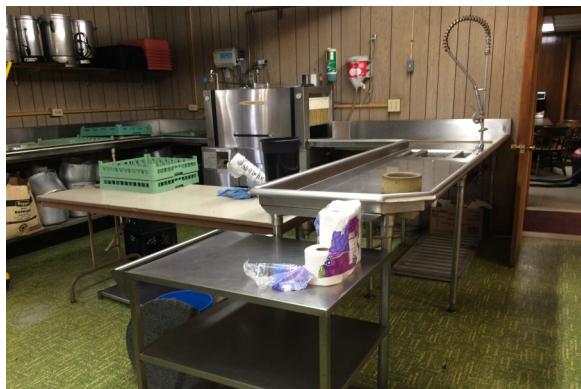
13.a.6, 13.b.2.d

1. A considerable amount of the existing materials and finishes in the Kitchen are damaged, deteriorated and cannot be properly cleaned / sanitized. Examples of these conditions are described in other sections of this report.
 - a. Areas of the plaster ceiling are sagging and stained from leaks above, are cracked providing areas for vermin / insects to enter. Additionally, with the considerable surface-mounted piping, light fixtures, etc., cleaning of the ceiling required by general "normal" kitchen activities would be difficult. A prior repair utilizing what appears to be 1/4" plywood is visible.
 - b. The resilient sheet flooring has areas of damage "repaired" with "duct tape".
 - c. The wood paneling on the walls is not sanitary and cannot be properly cleaned.

- a. The cooking fire suppression hood is substandard (Refer to pages 28, 29).
- b. The walk-in cooler behind the bar is not operational.
- c. Two ovens (of three), and five (of the eight) range burners work properly.
- d. A water leak has been noted to occur at times in the dishwashing area.

5. All food service equipment should be evaluated by a kitchen equipment service company to establish the condition of all existing equipment.
 - a. Equipment that is not serviceable should be removed and replaced if necessary for on-site food preparation.

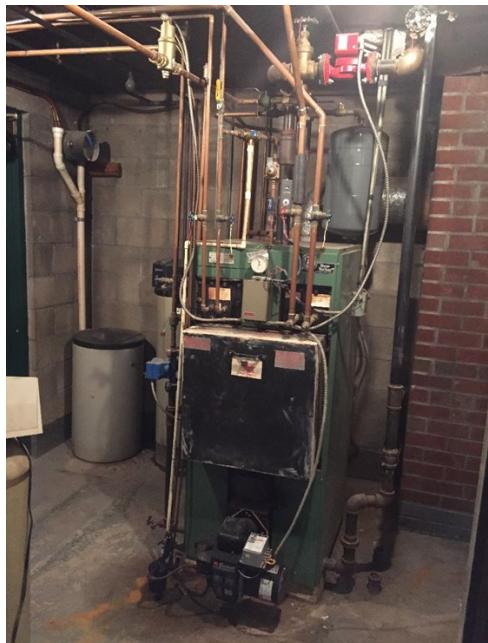
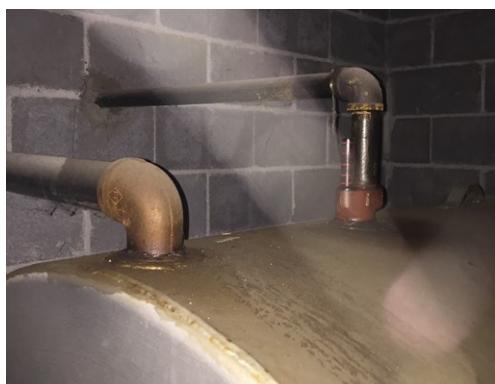
3.a, 3.b

The building is primarily heated by an oil-fired hot water boiler feeding baseboard radiant hot water convectors. The New Yorker Boiler is in fair condition and appears it has recently been outfitted with a new Beckett burner. The system heat output rate is 350,000 BTUH.

The system is a small feed oil pump that is connected to an approx. 750 gallon oil tank. The tank is located above grade in a small room off of the building Office. The only access to this room that was found is through a window in the Office.

The only deficiency noticed was the lack of proper combustion air in the Boiler Room. That said, if the system has fired appropriately throughout its life, the construction is likely loose enough to draw the combustion air.

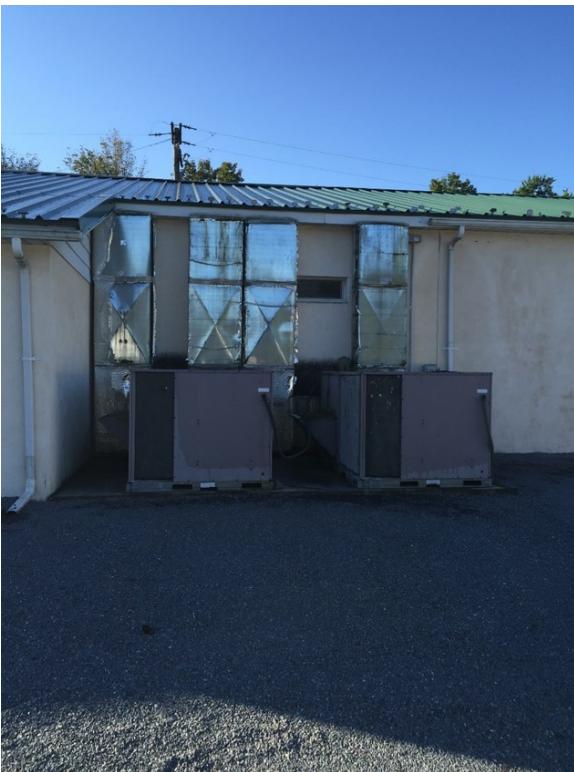
4.a, 4.b

One major deficiency noted was the lack of insulation on the ductwork. The absence of the insulation (exterior and interior) is an energy code violation, plus it drives up the cost of operation.

It is recommended that all supply and return air ductwork be insulated. Insulating existing ductwork above ceilings is often difficult, but should be considered to cut operational costs. Budget preparations shall also be made for replacement of the cooling units. This type of equipment typically has a life cycle of about 15 years.

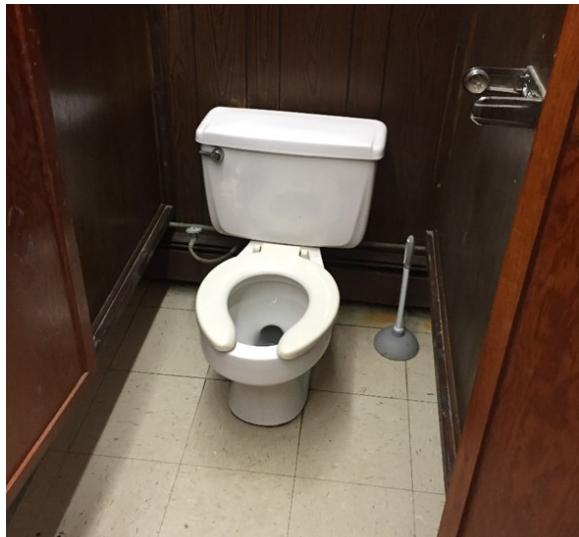
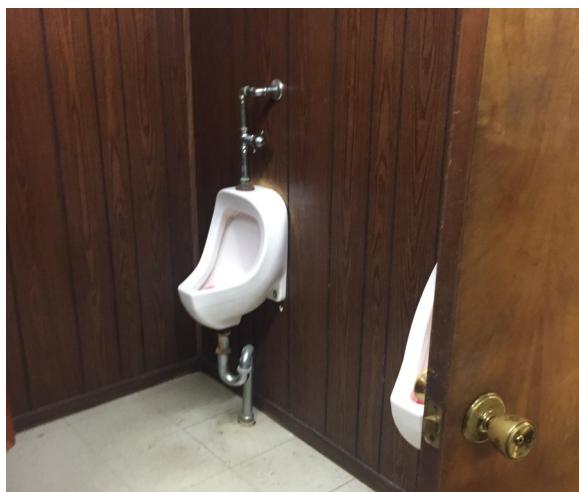
5.a

No deficiencies were noted in terms of drainage or the septic system. The septic tank however was not inspected. The plumbing fixtures as a whole are dated.

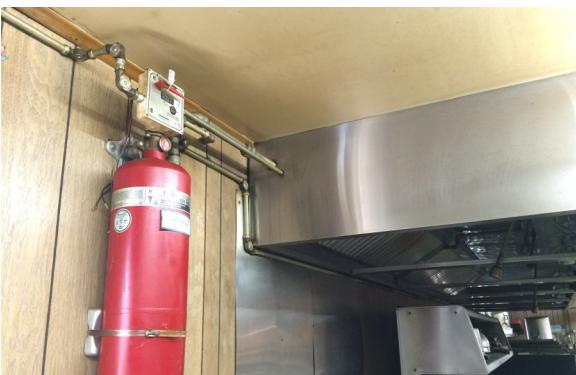
7.b

The Kitchen has numerous items that should be addressed.

1. Electrically, none of the receptacles appear to be GFI. Receptacles located in close proximity to water should be protected.
2. The surface-mounted lighting above food preparation areas do not meet code. These fixtures require a shatterproof lens.
3. A grease interceptor is recommended /required to capture grease before it enters the sanitary system.
4. All of the sinks' sanitary is hard piped. Fixtures used for food preparation, dishwashing, etc. are required to have an air gap so sanitary backups cannot enter the fixture. This is typically handled by discharge into a floor sink.
5. The Kitchen exhaust system does not appear to have a means of makeup air. This could cause dramatic temperature swings and pressurization issues within the space.
