EXISTING BUILDING CONDITIONS ANALYSIS & ASSESSMENT
EAST PENN SOCIAL HALL
403 Blue Mountain Road, Ashfield PA
East Penn Township, Carbon County PA

02 December 2016

RE: Existing Building Conditions Analysis & Assessment

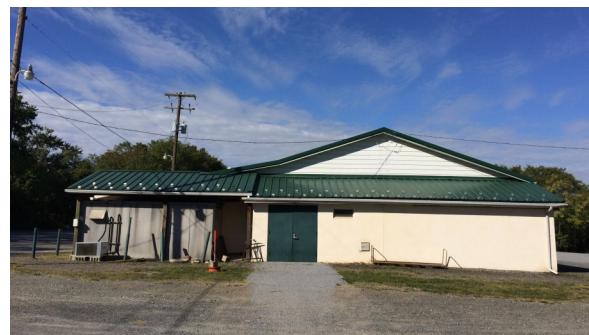
2.a

The building has a metal standing seam roof that appears to have been fairly recently replaced. Two rows of individual metal snow guards were installed in alternating panels between ribs.

The existing eave-ends of the metal roof installation are open to the elements, appearing to lack closure in the voids below corrugations. This could potentially lead to water infiltration into the building. It is unclear what type of eave starter trim was installed. Previous snow or ice accumulation appears to have been too heavy to be retained by the snow guards and deformed numerous snow guards so as to render them non-functional.

To ensure watertight conditions of the building, closure strips should be installed in gaps below corrugations and vertical end seams sealed. Replace damaged individual snow guards per manufacturer's installation recommendations with thicker gage product. Repair cracks, loose edges.

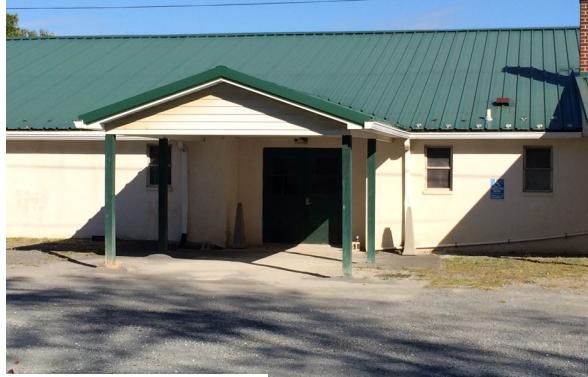
4.a, 5.b, 6.b.9

The main public entrance to the building / approach from the parking lot consists primarily of compacted gravel, with a concrete landing (approximately 3' deep) immediately outside the door. The gravel surface in this area is irregular and could pose a tripping hazard. This area would not be considered a handicapped accessible route.

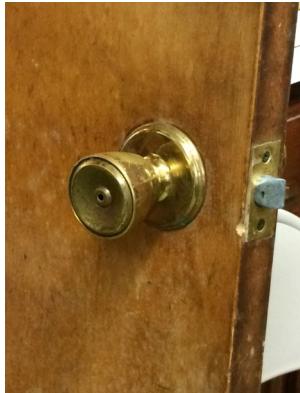
6.b.1

- Doors throughout the building have round doorknobs, many doors do not have appropriate wheelchair clear floor areas.
- Certain finished floor surfaces are loose and / or unstable.

1. Round doorknobs throughout should be replaced with lever sets, typical. Where feasible to move, or when doors are relocated, provided required clearances shall be provided. Thresholds and transition strips that exceed allowable heights (1/4" vertical change in level or combined change of 1/4" vertical plus 1/4" beveled) should be replaced with new accessible thresholds.

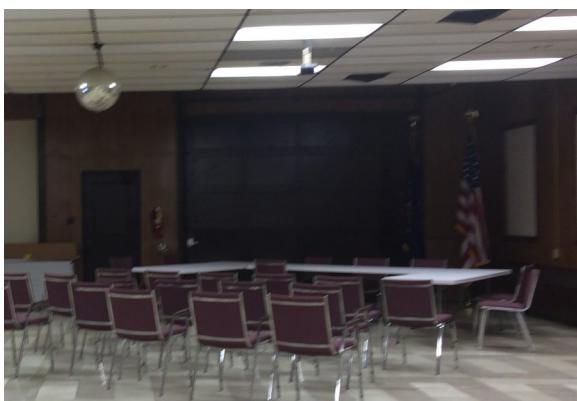
7.a.3, 7.a.4

1. The ceiling plane is generally of uniform height and is located as high as realistically possible.
3. An existing overhead sectional door to the adjacent fire station is no longer utilized. This also causes a negative visual impact.
4. A single man-door connects the adjacent Post Office with the Township Social Hall. This could potentially create a security concern between the two spaces. This door is used by the Post Mistress to access the toilet room facilities in the Township Social Hall, so a connection must be provided.

5. The existing overhead door into the Fire Hall space that is no longer in use should be removed and the opening infilled.
6. Replace existing exterior doors with prefinished, insulated units.

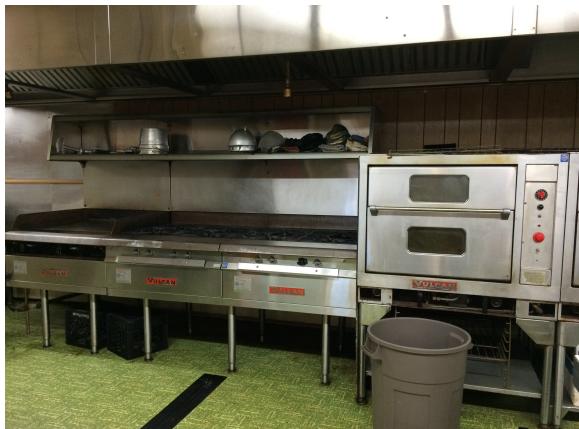
13.a.8, 13.b.2.a, 13.b.2.c

1. A considerable amount of the existing materials and finishes in the Kitchen are damaged, deteriorated and cannot be properly cleaned / sanitized. Examples of these conditions are described in other sections of this report.
 - a. Areas of the plaster ceiling are sagging and stained from leaks above, are cracked providing areas for vermin / insects to enter. Additionally, with the considerable surface-mounted piping, light fixtures, etc., cleaning of the ceiling required by general "normal" kitchen activities would be difficult. A prior repair utilizing what appears to be 1/4" plywood is visible.
 - b. The resilient sheet flooring has areas of damage "repaired" with "duct tape".
 - c. The wood paneling on the walls is not sanitary and cannot be properly cleaned.

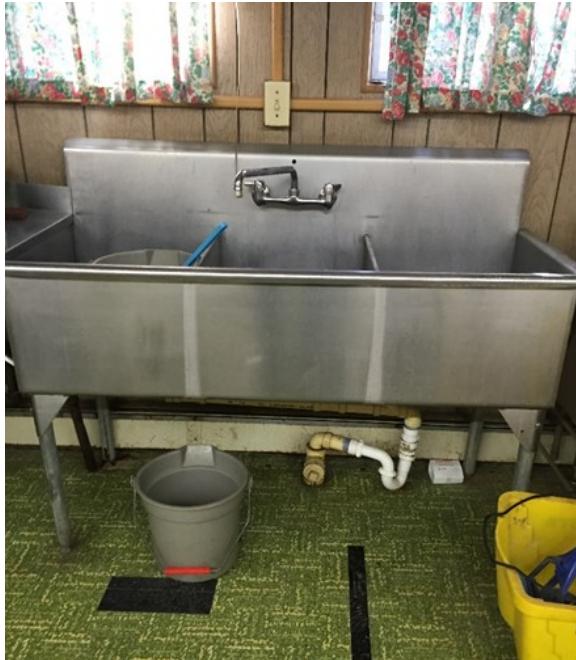
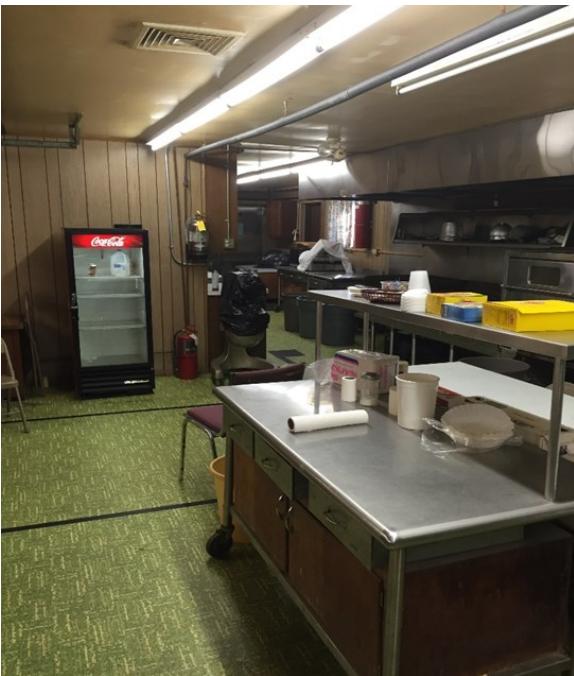
7.a

The Kitchen has numerous items that should be addressed.

1. Electrically, none of the receptacles appear to be GFI. Receptacles located in close proximity to water should be protected.
2. The surface-mounted lighting above food preparation areas do not meet code. These fixtures require a shatterproof lens.
3. A grease interceptor is recommended /required to capture grease before it enters the sanitary system.
4. All of the sinks' sanitary is hard piped. Fixtures used for food preparation, dishwashing, etc. are required to have an air gap so sanitary backups cannot enter the fixture. This is typically handled by discharge into a floor sink.
5. The Kitchen exhaust system does not appear to have a means of makeup air. This could cause dramatic temperature swings and pressurization issues within the space.
